To: Newport MUD  
From: Brent Fleischer, E.I.T.  
Re: Sanitary Sewer Phase 1 Rehabilitation

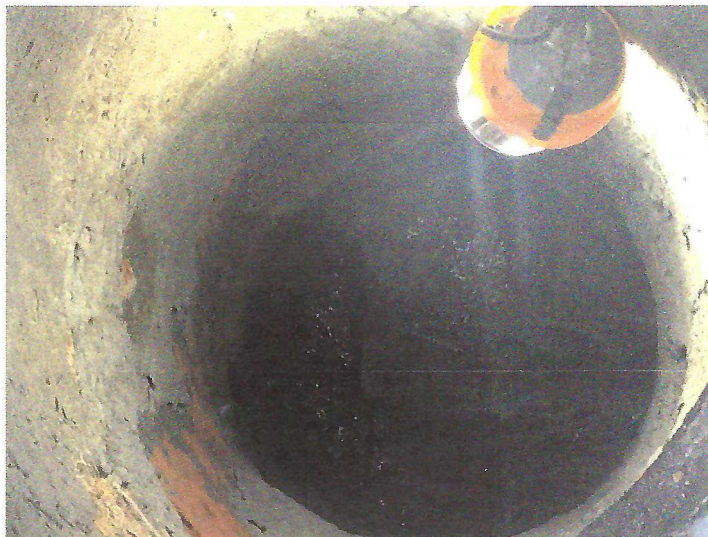
The two manholes that were included in this rehabilitation project were severely deteriorated from sewer gases and high sewer flows from the force mains. Parts of both manholes were in critical condition with some of the concrete walls being completely eroded away. Where the portions of the concrete wall were missing, dirt and sand were the only things preventing the manholes and roadways from collapsing, causing concern.

*Manhole #1: Existing Deteriorated Condition*

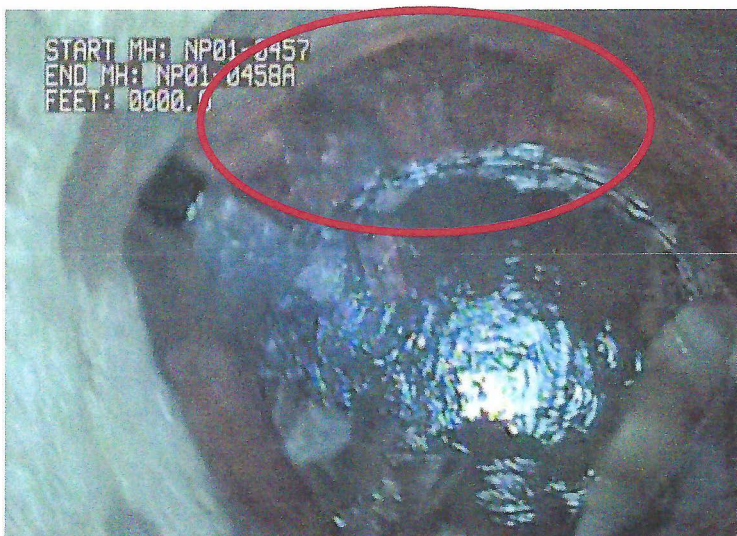
*Manhole #1: Existing Hole in Back Wall*

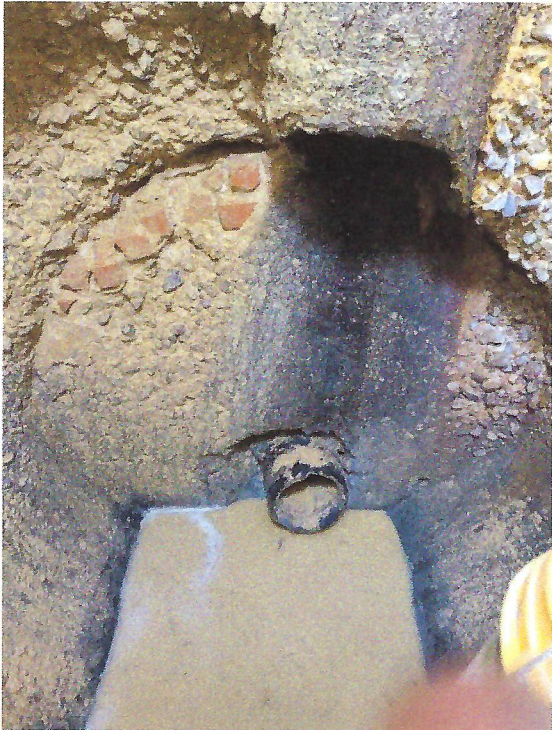
*Manhole #2: Fully Eroded Back Wall with Only Dirt and Rocks Supporting the Manhole*

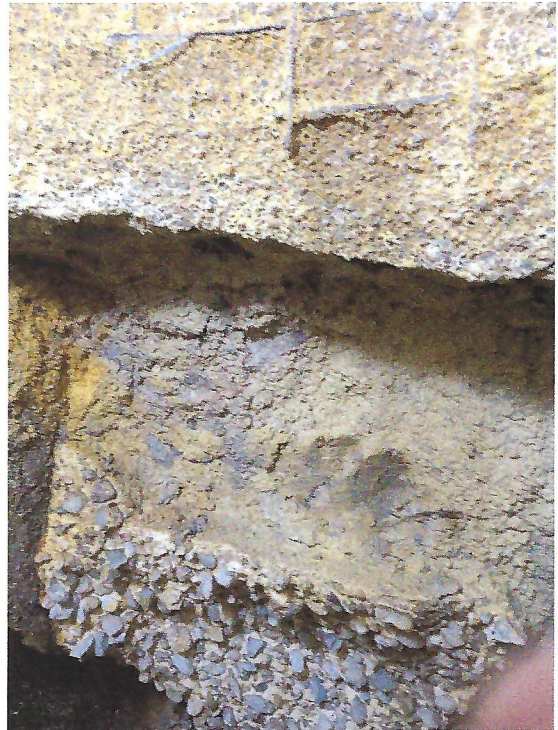
*Manhole #2: Fully Eroded Side Wall with Exposed Dirt. Remaining Concrete has Exposed Rebar.*
